Dutchman's Pipe Cove Roofing Maintenance

Re: Dutchman's Pipe – Water intrusion in rear of various units

The purpose of this letter is to address our inspection of the roof leak concerns on the rear of the Unit 28 at 2808 Dutchman's Pipe in Greensboro, North Carolina. The inspector from our company visited the jobsite on December 1st, 2009 to inspect, photograph, and measure the area of concern.

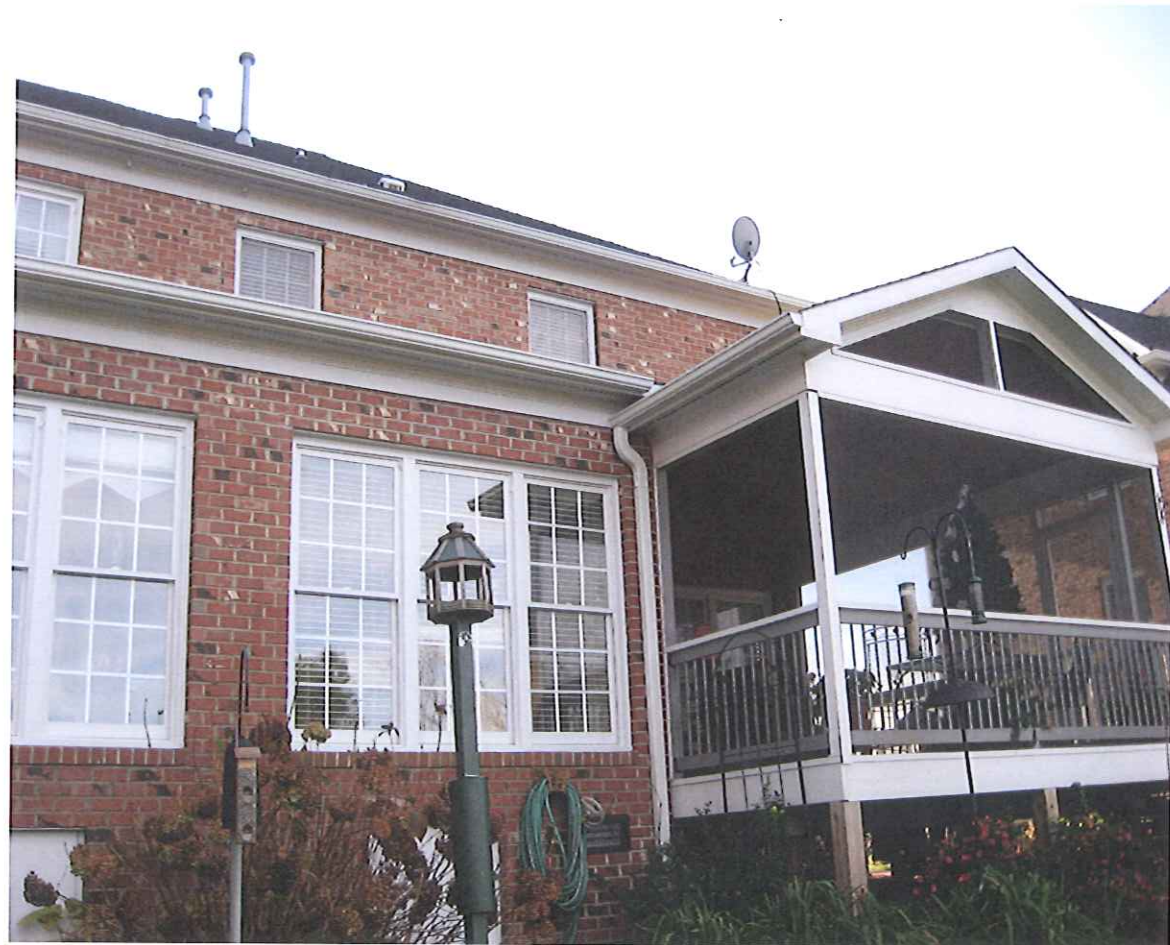
Water has been entering the ceiling of 1st floor to the rear of the kitchen.

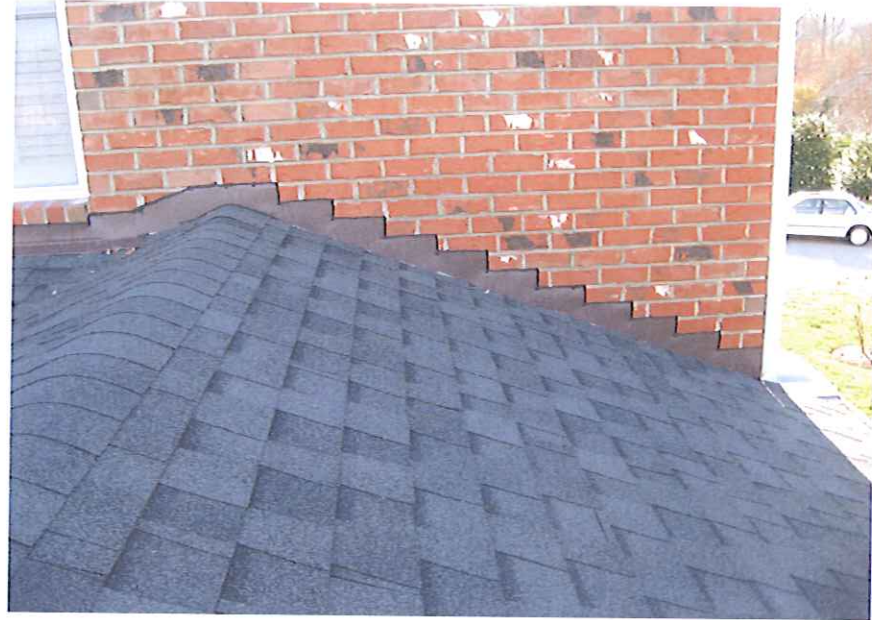
It is my opinion that the water entering the ceiling below is passing through the brick veneer and traveling down the house wrap into the attic space (see enclosed sketches). This may be alleviated by either preventing the water from penetrating the brick or channeling it to the roof below before it enters the space over the ceiling.
