Swansgate HOA
2808 Churchill Ct
Highpoint, NC 27262

An inspection of the stormwater ponds were completed on 9/13/24, and the findings indicate that the all the ponds, while currently functioning, are in need of some maintenance work to ensure they stay in working order. This particular community is in a difficult situation to manage as the ponds are on private property but the HOA still has an obligation to maintain the stormwater ponds. The stormwater regulations in NC were not as detailed when these ponds were likely constructed and they have likely been “grandfathered” in. They don’t necessarily fall under the same scrutiny as new construction. However, municipalities are aware of this and have begun going back to older systems and requiring several updates for functionality.

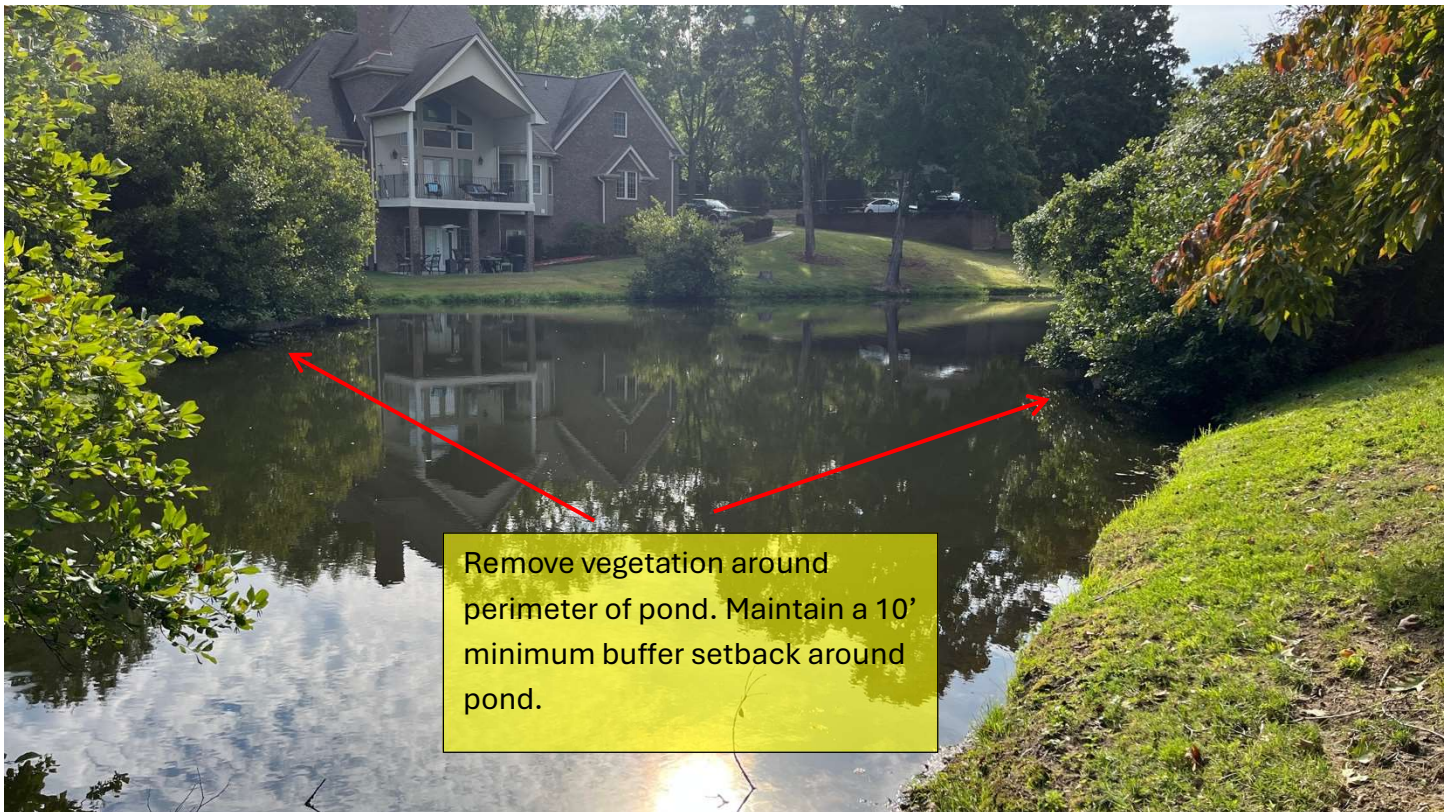
SG1

Pond has some weeds growing around the edges in the water. This indicates some sediment build up that can facilitate weeds. Organic sediment can be broken down with a beneficial bacteria program.

The retaining wall on the inlet side of the pond was noticed to be leaning. It was learned that this is not structural to the integrity of the pond bank and there have been discussions on replacing it prior to our inspection.

Keep inlets and outlets free of weed growth and debris.

Depths do not justify a dredging operation at this time. Recommend cleaning out sediment at the time of retaining wall replacement.

Preliminary Estimate: \$5,500 – Tree removal and brush clearing around pond banks and dam. (Does not include cost to rebuild retaining wall)

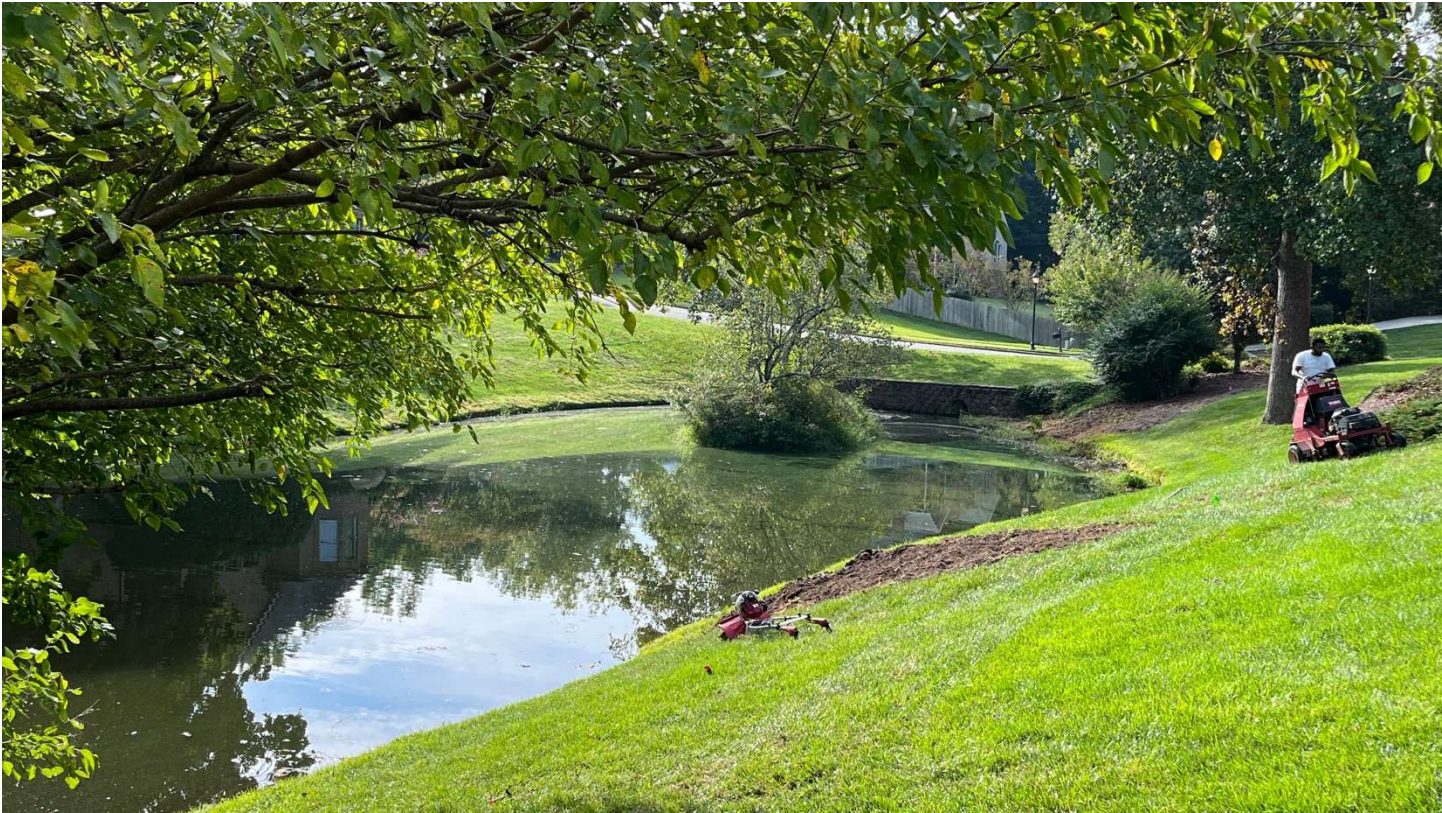
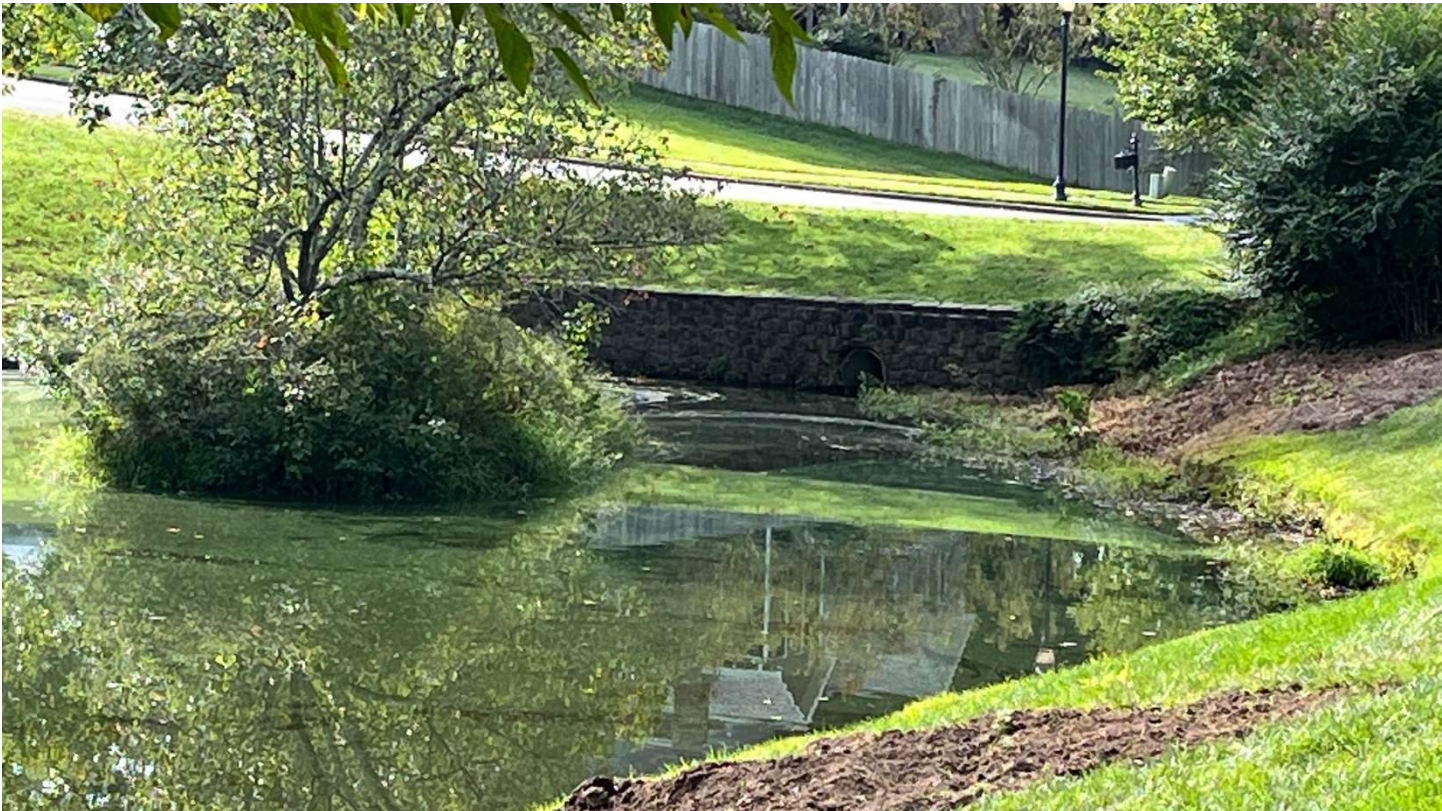
SG2

Suggest removing any woody-stem vegetation along dam.

Inlet swale needs reshaped and additional riprap stone placed to slow water velocity down prior to entering pond.

Weed growth in current riprap indicates sediment build up over time.

Preliminary Estimate: \$4,000 – Reshape inlet and redo dissipator pad with riprap and separation fabric. Includes minor brush removal around pond banks (not much noted within buffer zone).

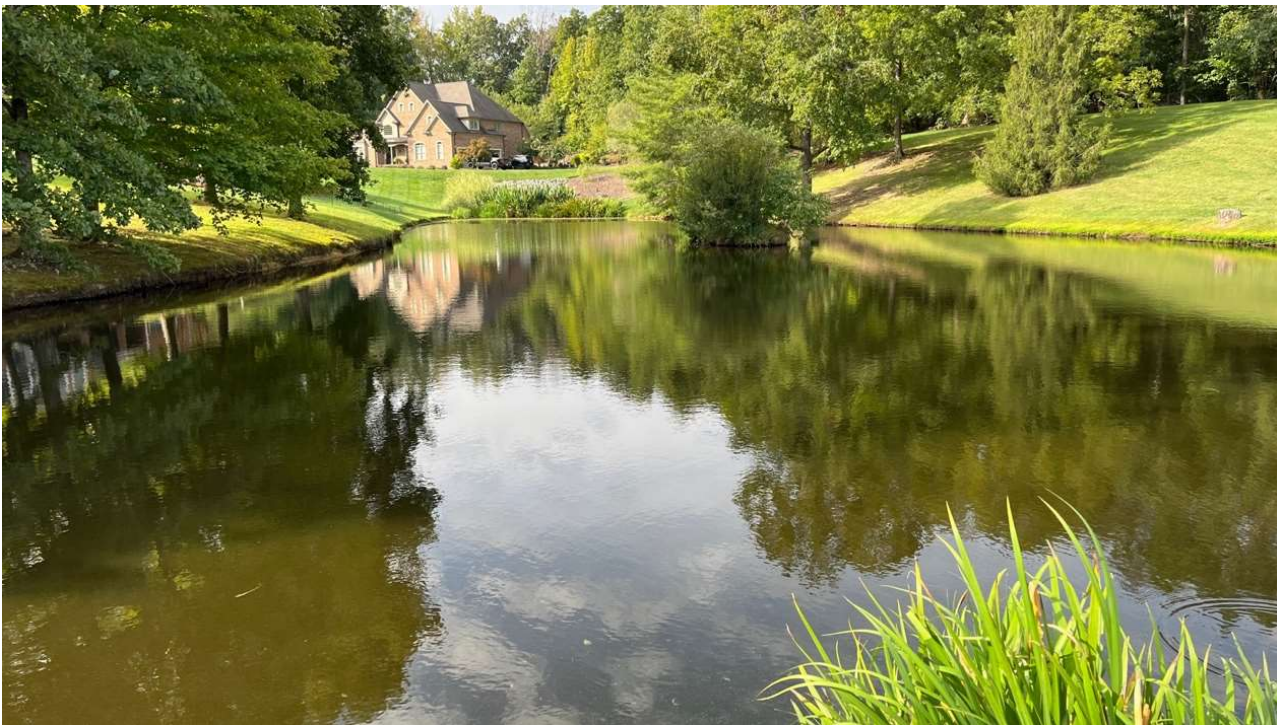
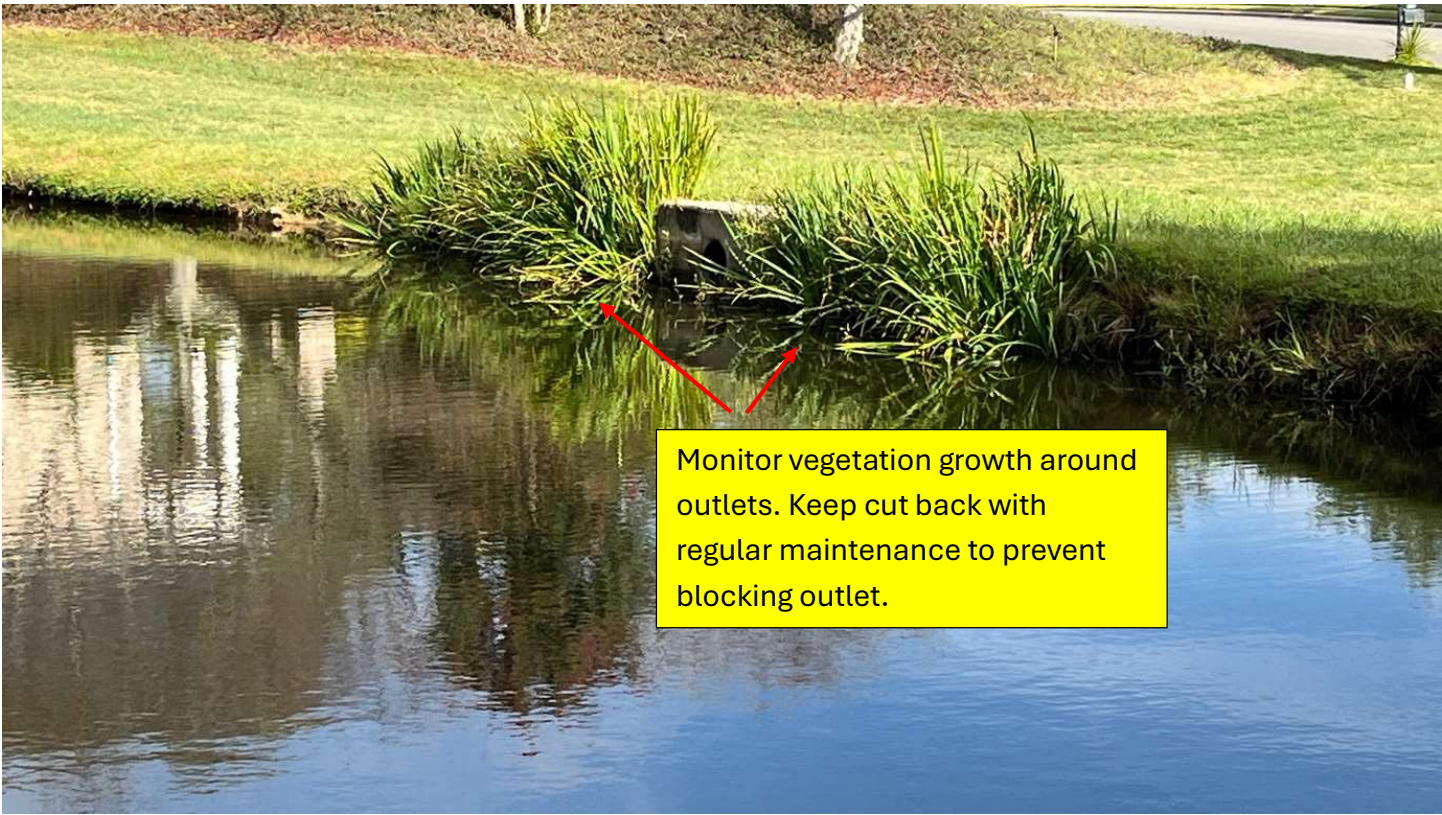
SG3

Outlet has vegetation growing around it. Need to keep this cut back to prevent matting and clogging of the outlet.

Inlet riprap needs reshaping however, the plants in the shallow marsh area are a benefit to this pond. The type of plants act as a natural filter that traps sediment and excess nutrients.

Keep an eye on bank erosion and any rodent activity with routine maintenance.

Preliminary Estimate: \$1,200 – reshaping of inlet riprap, reusing as much as possible. Removing any invasive plant species from inlet marsh area (cattails, blackwillows). Clearing vegetation from outlet.

Monitor vegetation growth around outlets. Keep cut back with regular maintenance to prevent blocking outlet.

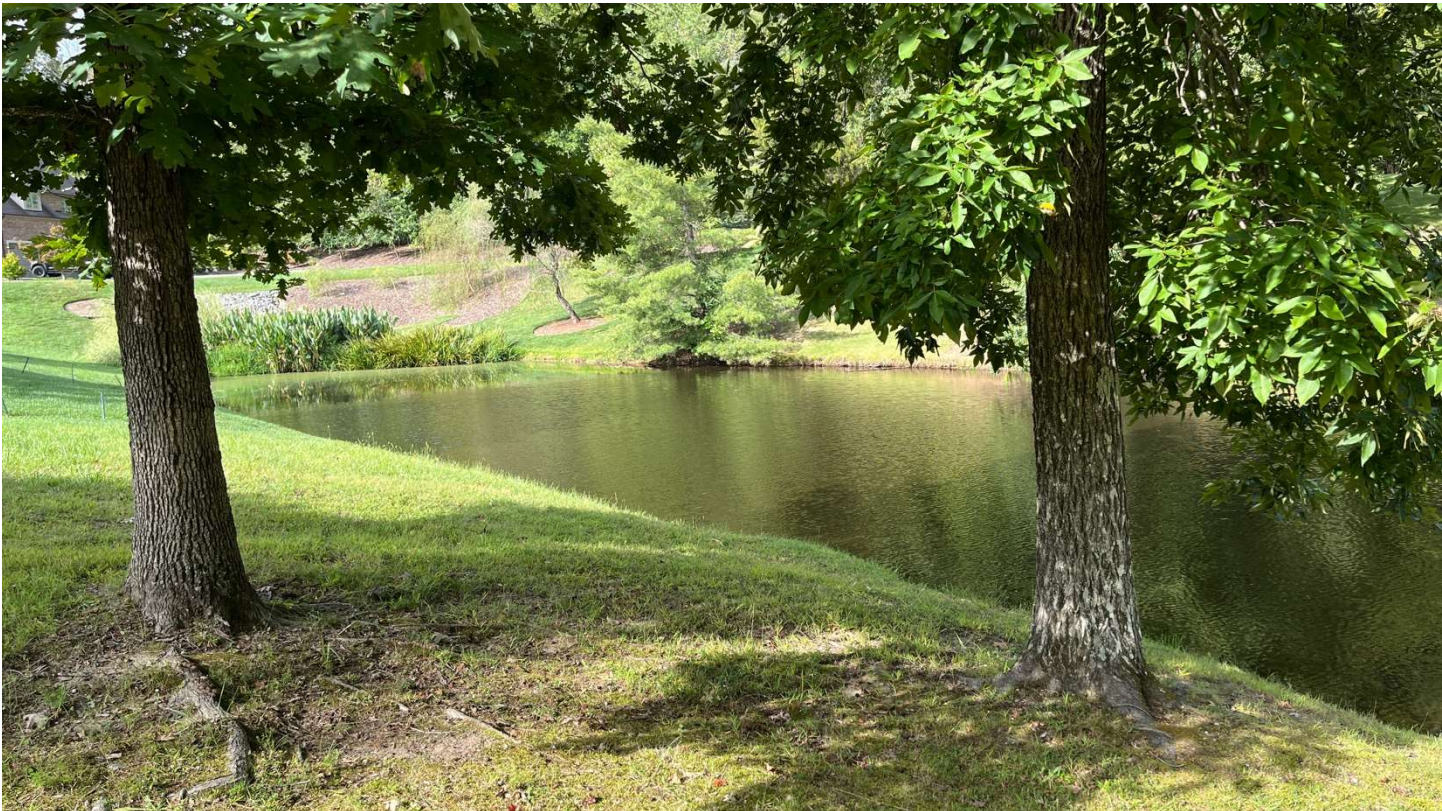
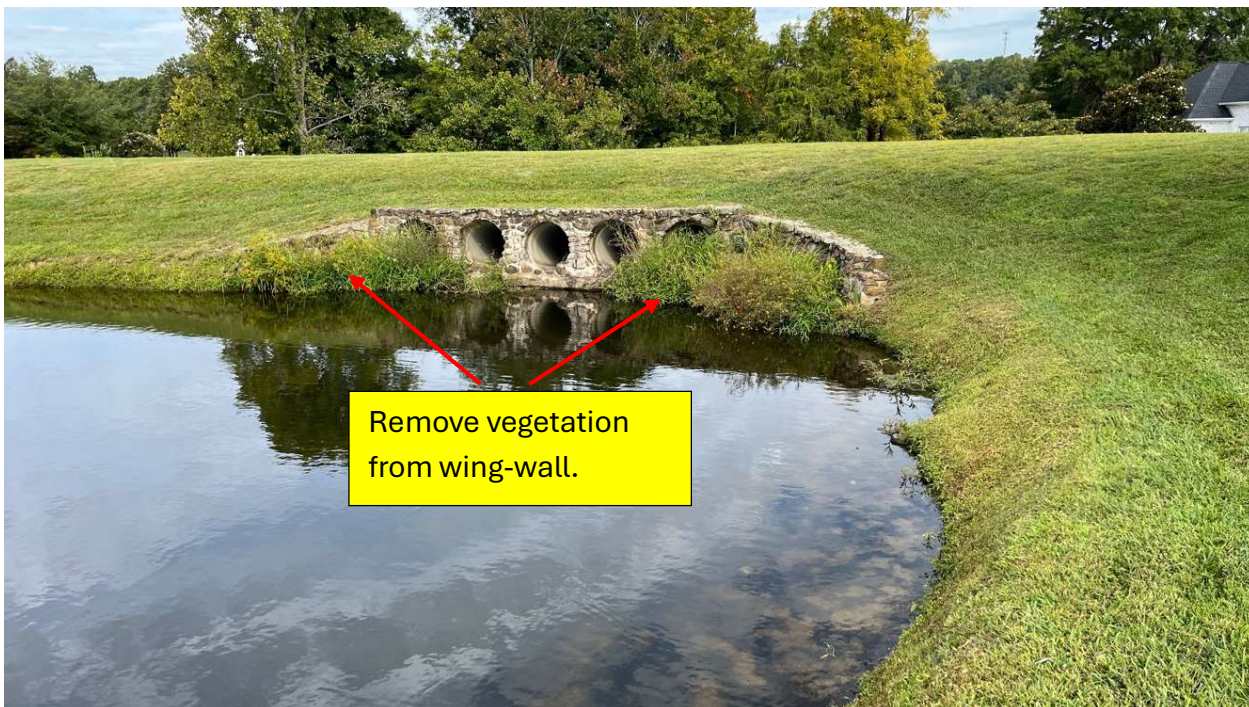
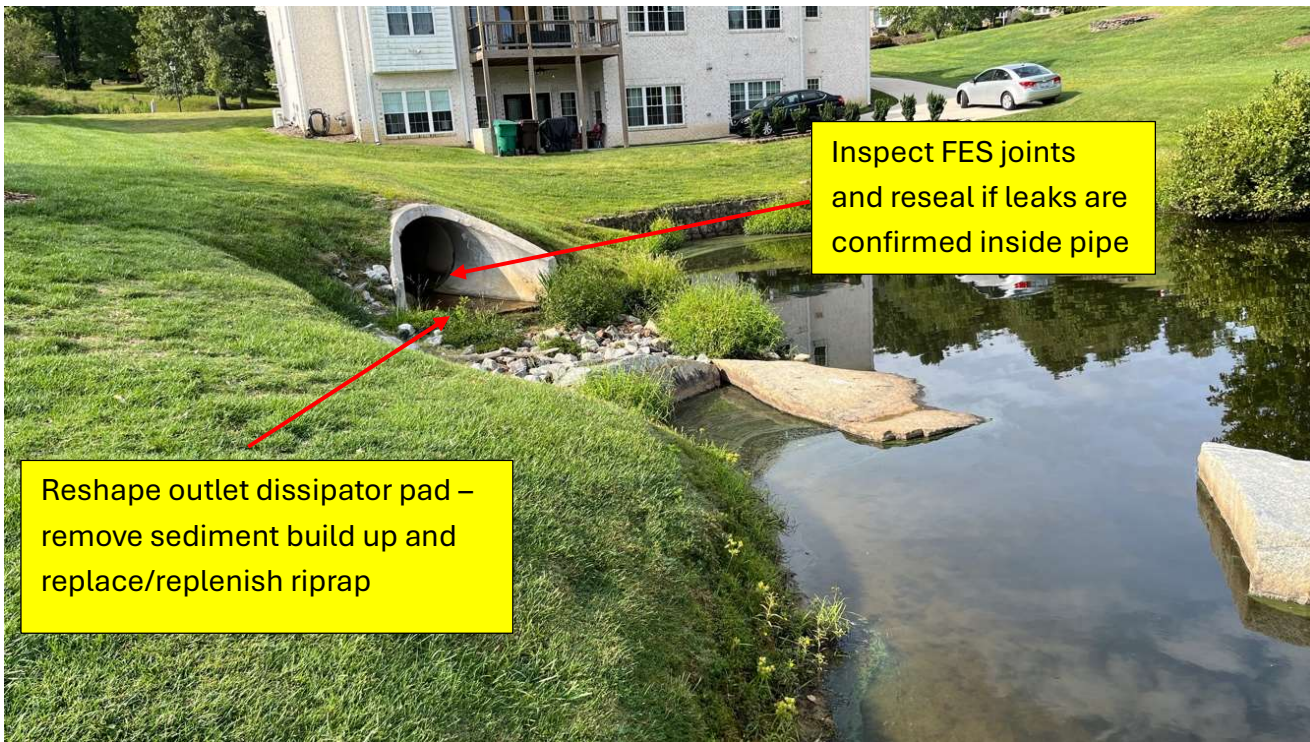
SG4

Large pond has weed growth around the emergency overflow that should be removed to prevent clogging. This should be removed and kept with original bare stone wing-wall.

Inlet in cove has significant sediment build up. Riprap is in need of reshaping/replacing. Erosion around the outside of the concrete FES (Flared End Section) indicates the joint inside the pipe is leaking and/or failed. This causes water to seep out that joint. Appears there was some type of concrete structure there originally that has dislodged and is out in the pond. These should be removed at the time of riprap replacement/sediment removal at outlet.

Backside of dam – the outlet discharge behind dam needs several trees removed and the drainage swale armored with riprap stone to prevent downstream erosion. The addition of a riprap dissipator pad will prevent downstream erosion and scouring of the adjacent landscape. The swale discharges into the downstream creek located on Rock Bridge Rd.

Preliminary Estimate: \$9,300 – Repairing existing FES in SW cove. Reseal FES joint inside pipe. Current FES is likely not damaged, only leaking at the joint. Remove sediment build up at FES. Remove and replace riprap dissipator pad with new stone and separation fabric.

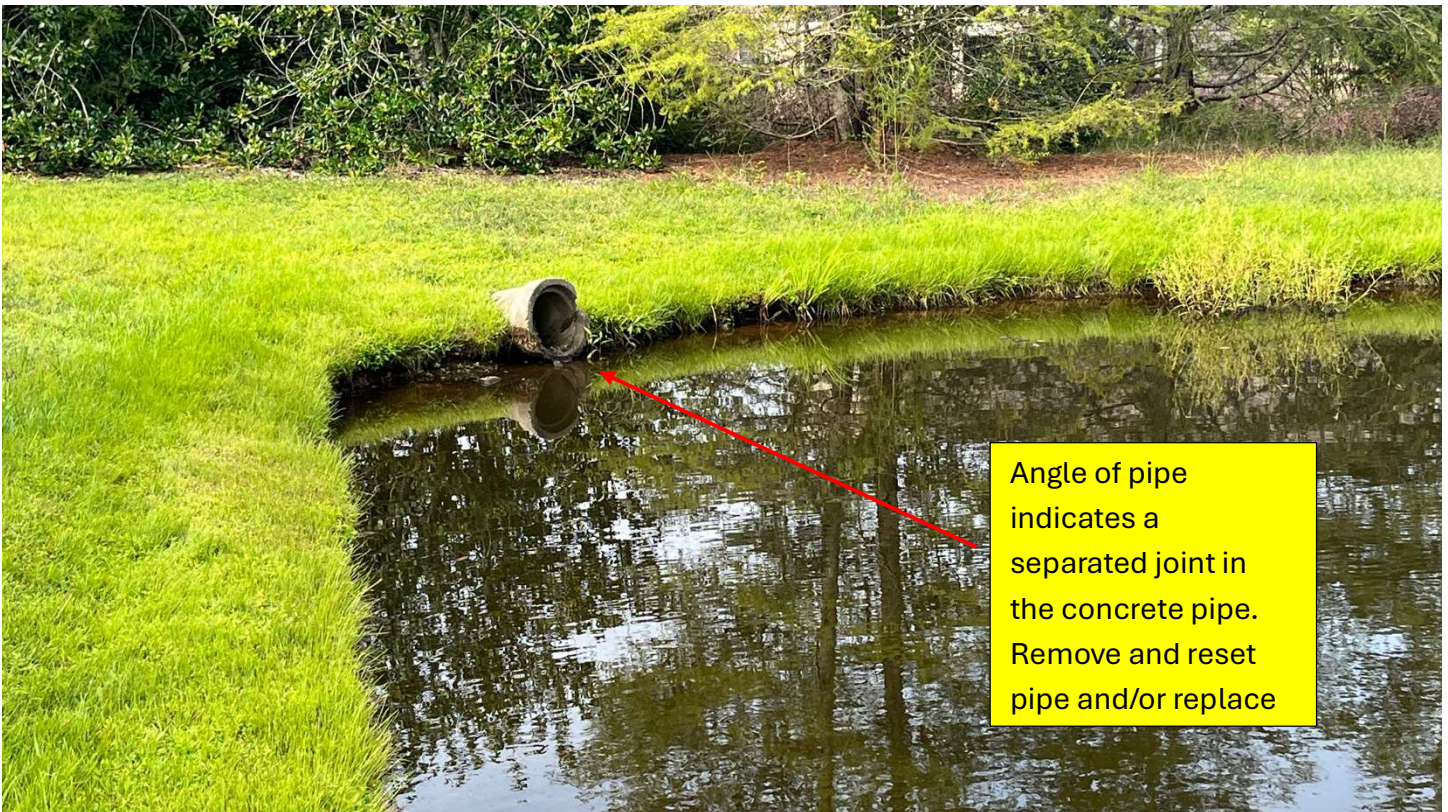
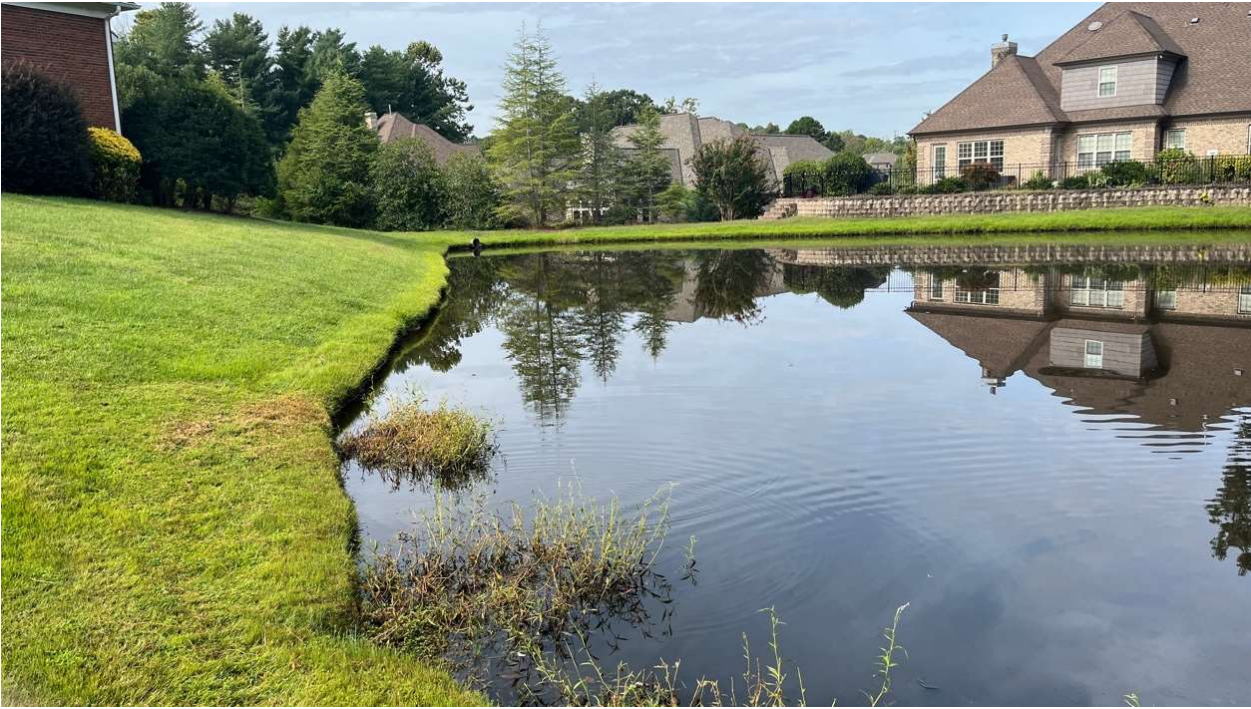
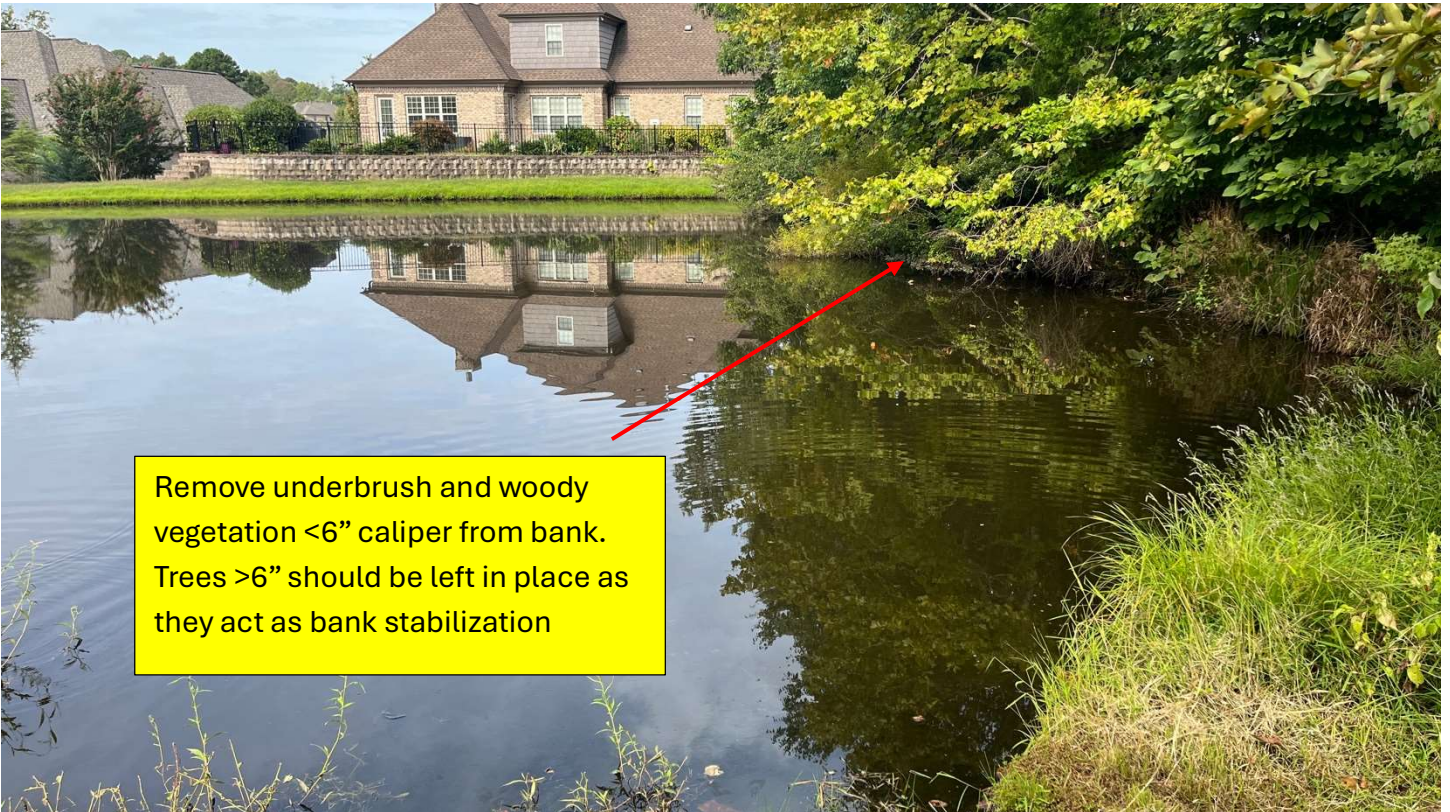
SG5

Inlet is tilted upward which caused water to pool inside pipe. This has the potential to create a breeding ground for mosquitos.

Consider repairing and adding riprap splash pool to slow water velocity coming in. Some minor sedimentation accumulating in pond at inlet.

Woody vegetation on western bank – as noted above, the trees 8” caliper and above should remain in place. Trees < 8” should be removed along with underbush.

Preliminary Estimate: \$5,800 | Removing all underbrush and trees under 6” caliper along northern pond bank.

Preliminary Estimate: \$4,200 | Inlet restoration – correct fix to be determined based on inspection of pipe interior.
