Dutchman's Pipe Cove Roofing Maintenance

Re: Dutchman's Pipe – Water intrusion in rear of various units

The purpose of this letter is to address our inspection of the roof leak concerns on the rear of the Unit 28 at 2808 Dutchman's Pipe in Greensboro, North Carolina. The inspector from our company visited the jobsite on December 1st, 2009 to inspect, photograph, and measure the area of concern.

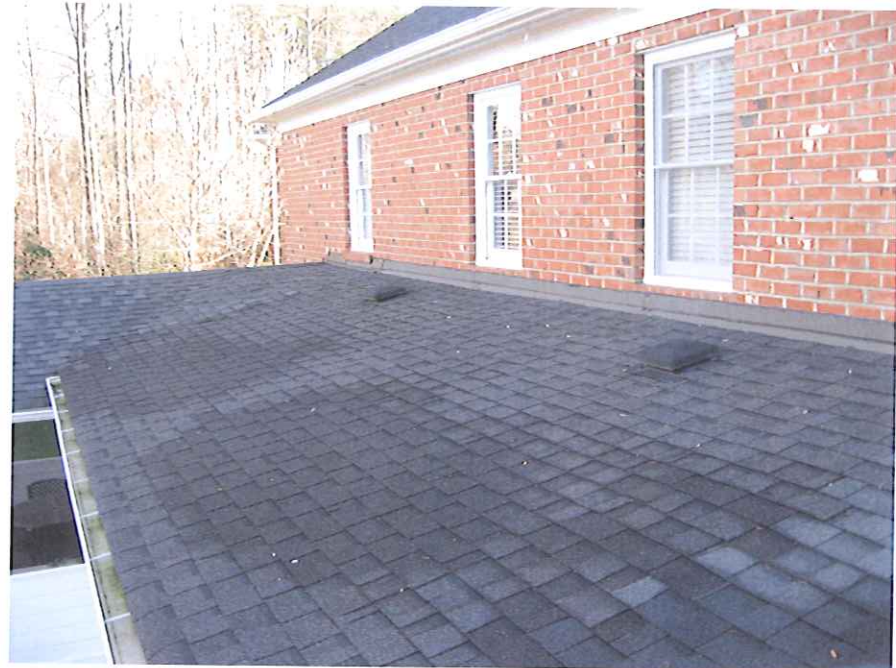
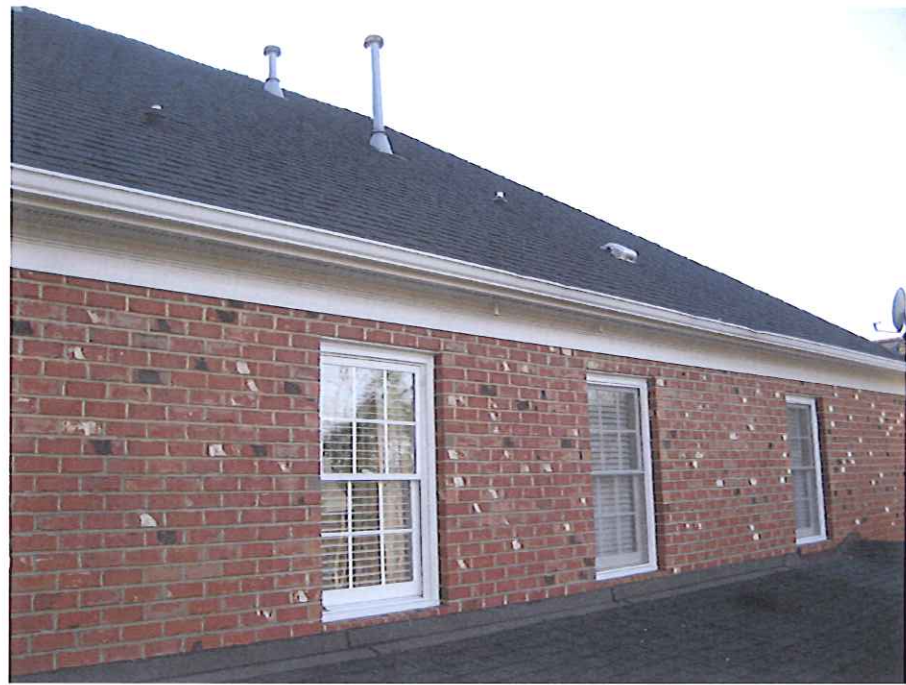
It is my opinion that the water entering the ceiling below is passing through the brick veneer and traveling down the house wrap into the attic space (see enclosed sketches). This may be alleviated by either preventing the water from penetrating the brick or channeling it to the roof below before it enters the space over the ceiling.

There are products available which coat the exterior of the brick veneer to prevent water penetration, but these are only as good as the applicator and must be reapplied periodically (every 4-5 years).

I recommend that a lower section of the brick veneer be removed and a more permanent solution be implemented. This method is outlined on the two enclosed sketch pages.

This solution offers the best long term protection from future water intrusion into the home at this location.
