Swansgate HOA
2808 Churchill Ct
Highpoint, NC 27262

An inspection of the stormwater ponds were completed on 9/13/24, and the findings indicate that the all the ponds, while currently functioning, are in need of some maintenance work to ensure they stay in working order. This particular community is in a difficult situation to manage as the ponds are on private property but the HOA still has an obligation to maintain the stormwater ponds. The stormwater regulations in NC were not as detailed when these ponds were likely constructed and they have likely been “grandfathered” in. They don’t necessarily fall under the same scrutiny as new construction. However, municipalities are aware of this and have begun going back to older systems and requiring several updates for functionality.

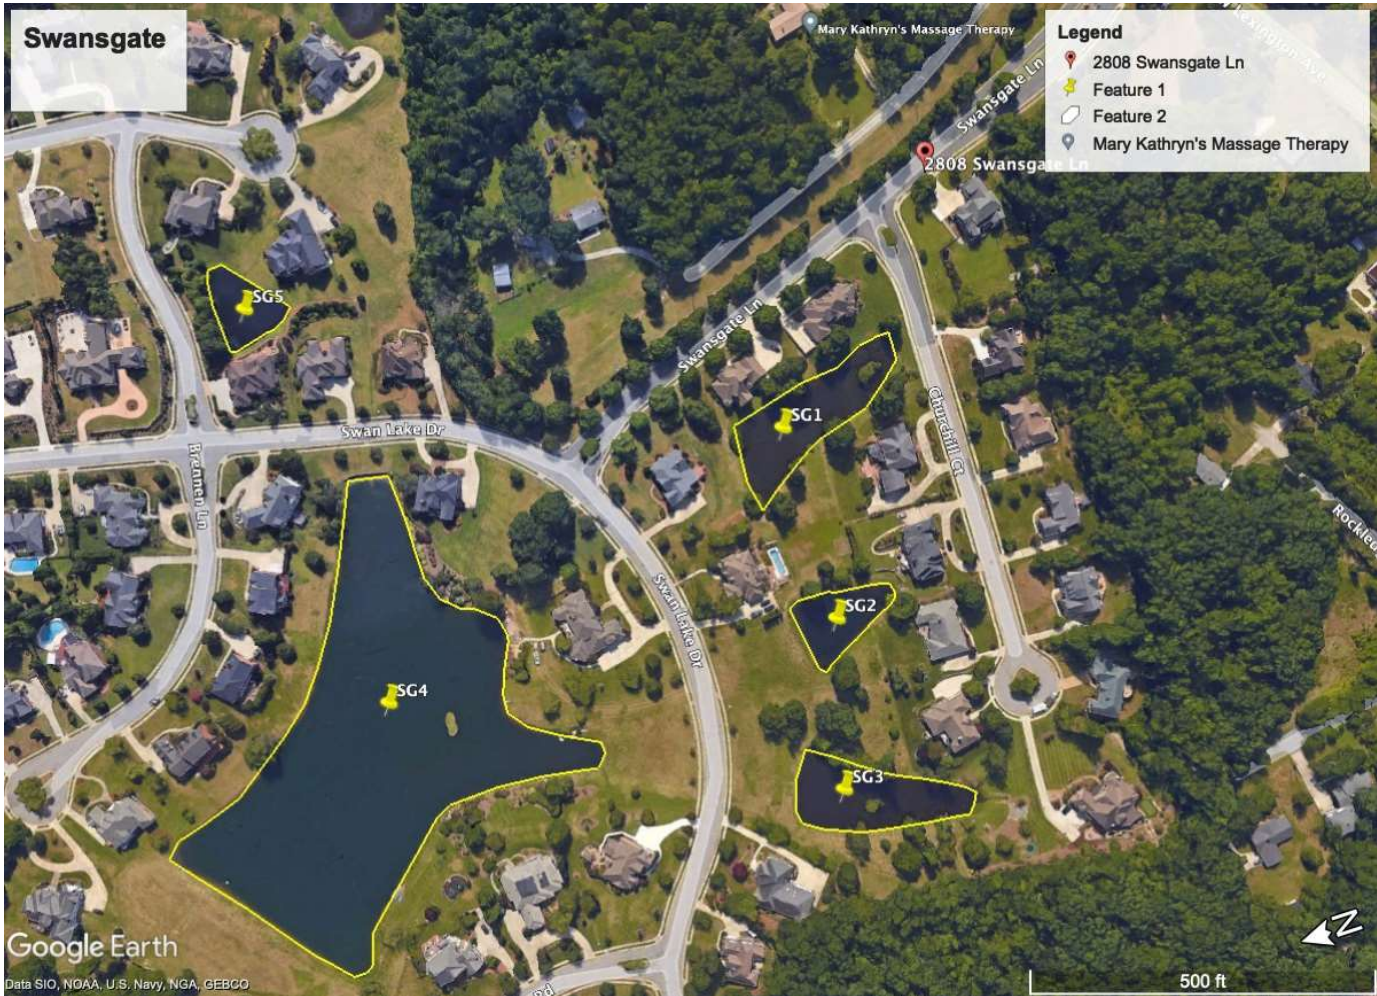
SG1

Pond has some weeds growing around the edges in the water. This indicates some sediment build up that can facilitate weeds. Organic sediment can be broken down with a beneficial bacteria program.

The retaining wall on the inlet side of the pond was noticed to be leaning. It was learned that this is not structural to the integrity of the pond bank and there have been discussions on replacing it prior to our inspection.

Keep inlets and outlets free of weed growth and debris.

Depths do not justify a dredging operation at this time. Recommend cleaning out sediment at the time of retaining wall replacement.

Preliminary Estimate: \$5,500 – Tree removal and brush clearing around pond banks and dam. (Does not include cost to rebuild retaining wall)

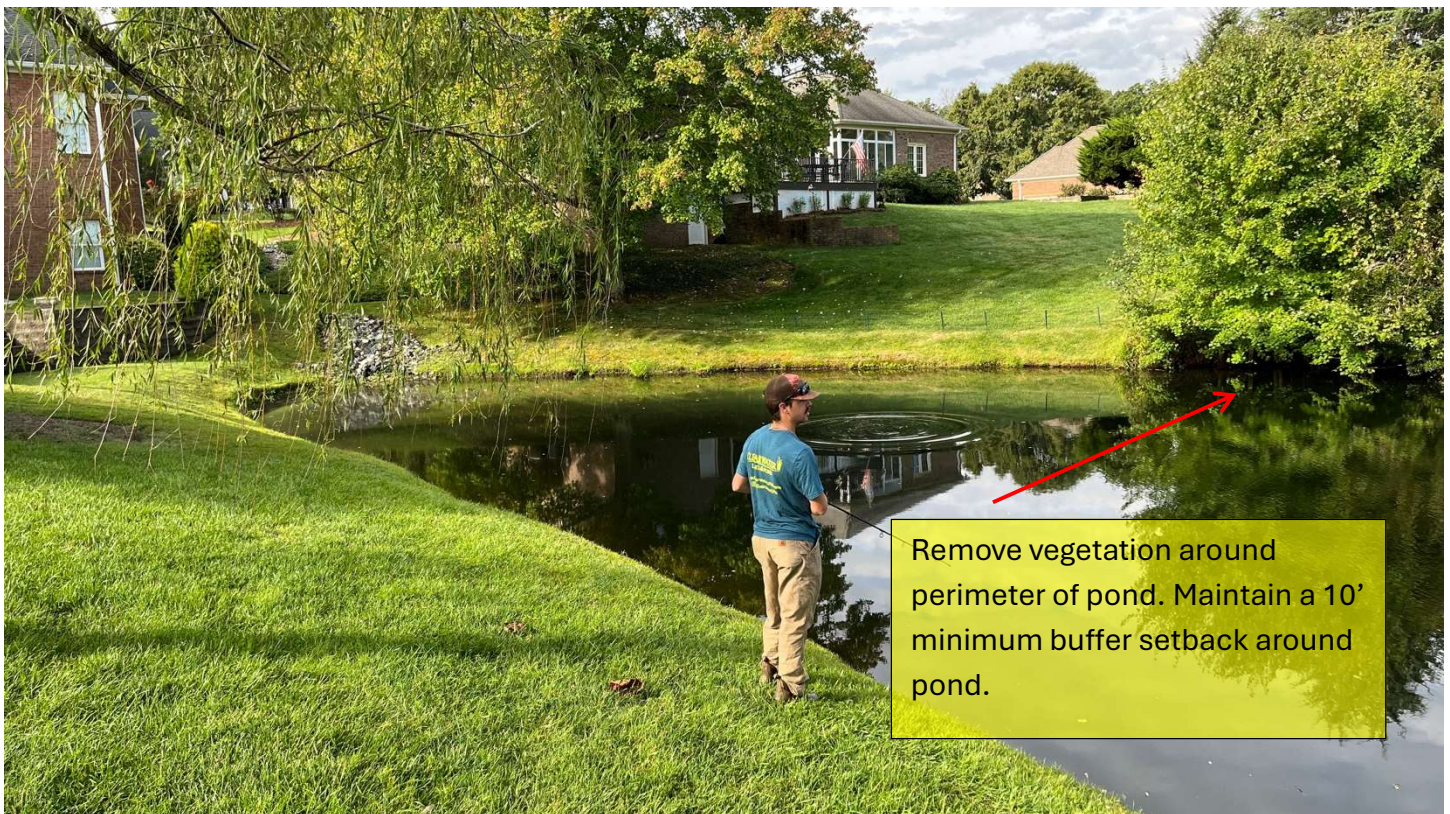
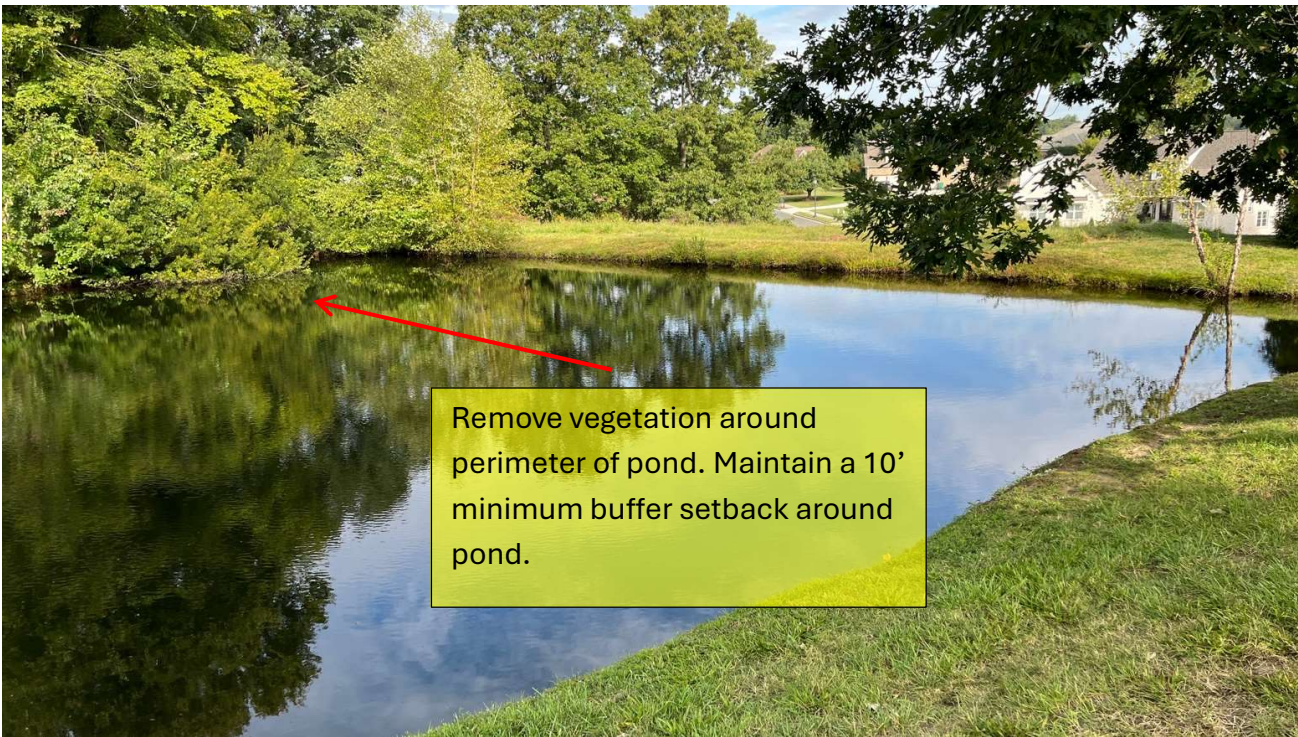
SG2

Suggest removing any woody-stem vegetation along dam.

Inlet swale needs reshaped and additional riprap stone placed to slow water velocity down prior to entering pond.

Weed growth in current riprap indicates sediment build up over time.

Preliminary Estimate: \$4,000 – Reshape inlet and redo dissipator pad with riprap and separation fabric. Includes minor brush removal around pond banks (not much noted within buffer zone).

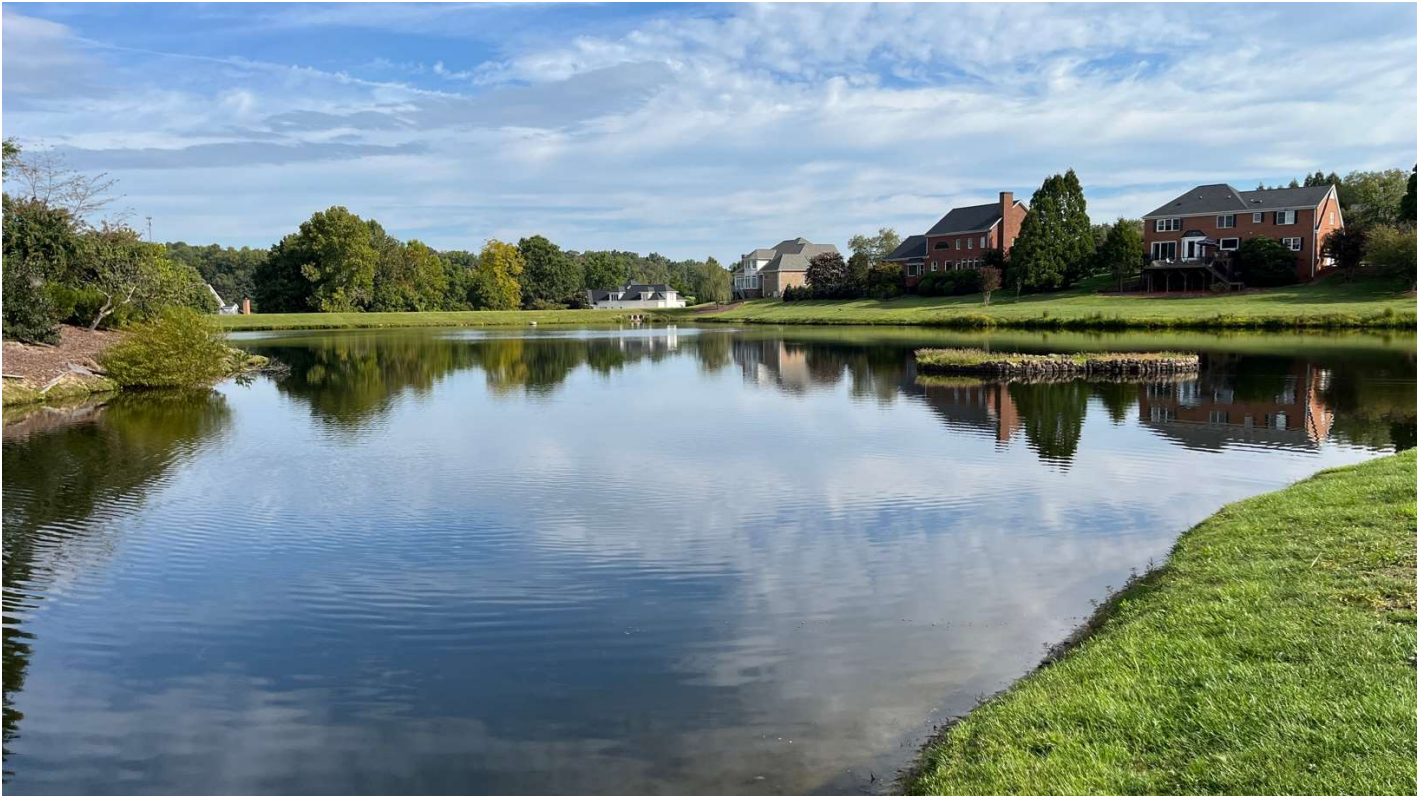
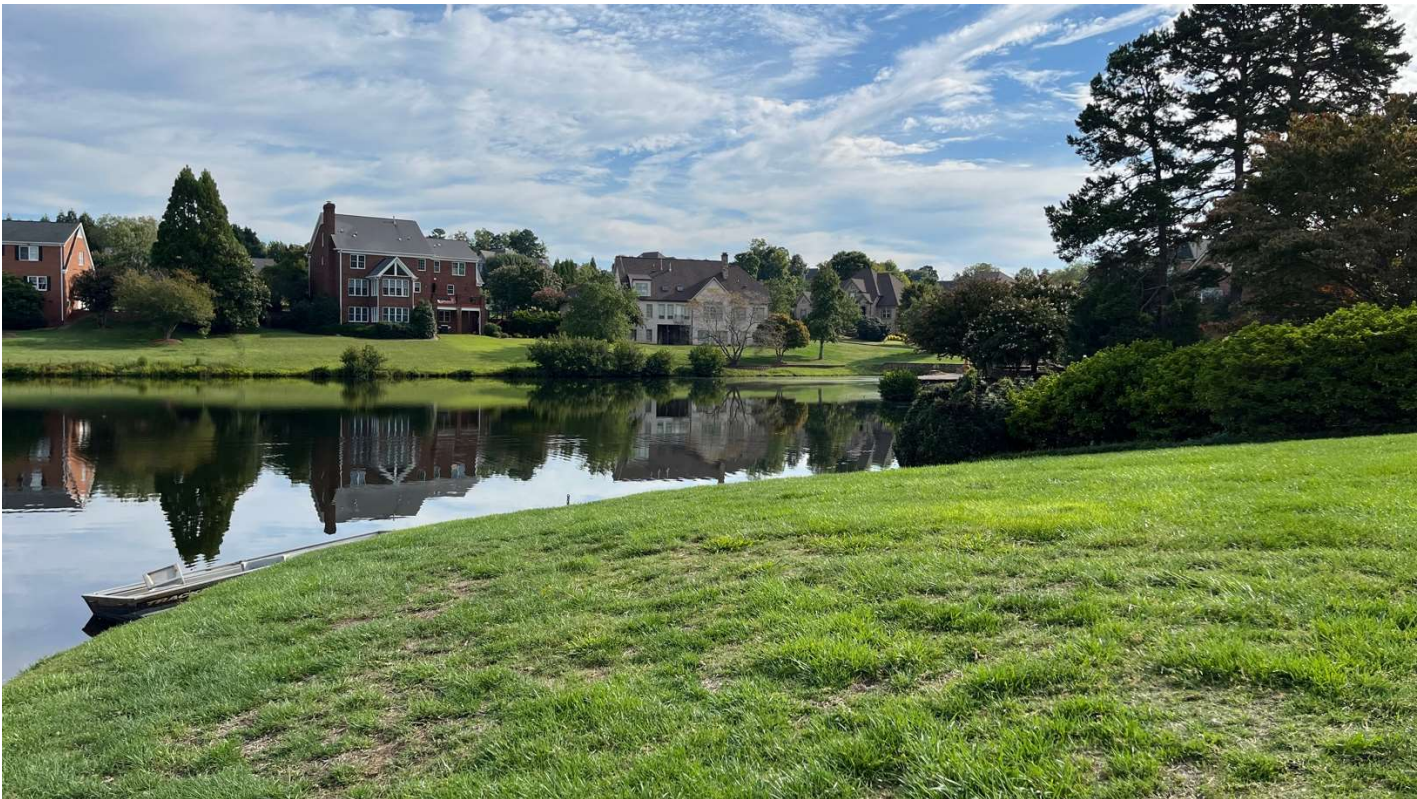
Inlet in cove has significant sediment build up. Riprap is in need of reshaping/replacing. Erosion around the outside of the concrete FES (Flared End Section) indicates the joint inside the pipe is leaking and/or failed. This causes water to seep out that joint. Appears there was some type of concrete structure there originally that has dislodged and is out in the pond. These should be removed at the time of riprap replacement/sediment removal at outlet.

Backside of dam – the outlet discharge behind dam needs several trees removed and the drainage swale armored with riprap stone to prevent downstream erosion. The addition of a riprap dissipator pad will prevent downstream erosion and scouring of the adjacent landscape. The swale discharges into the downstream creek located on Rock Bridge Rd.

Preliminary Estimate: \$9,300 – Repairing existing FES in SW cove. Reseal FES joint inside pipe. Current FES is likely not damaged, only leaking at the joint. Remove sediment build up at FES. Remove and replace riprap dissipator pad with new stone and separation fabric.
